Manhole Inspection Summary

Manhole # S350__065MH

Insp Date: **1/23/08 11:11 AM**

Location Address: **william st**

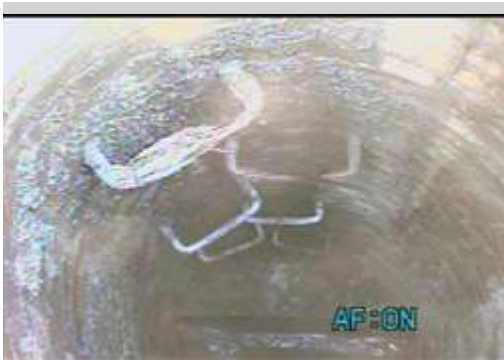
Defect 1

Condition: ☐ Sound ☐ Cracked ☐ Root Intrusion ☐ Loose Brick ☒ **Deteriorated**

Infiltration: ☐ None ☒ **Joint** ☐ Cracks ☐ Mortar ☐ Roots ☐ Wall

Count: **6** Missing: **0** ☒ **Corroded**

Corroded steps, Corbel Infiltration and Deterioration

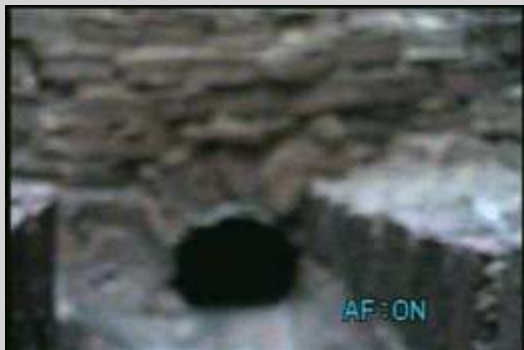
12 O'Clock Outflow

8 in. Circular Gravity Sewer
Pipe Out @ 12 O'Clock

Invert Depth: **10.00** (ft.) Flow Characteristics: **Slow**

Infiltration: **None** Pipe Seal Cond: **Unknown**

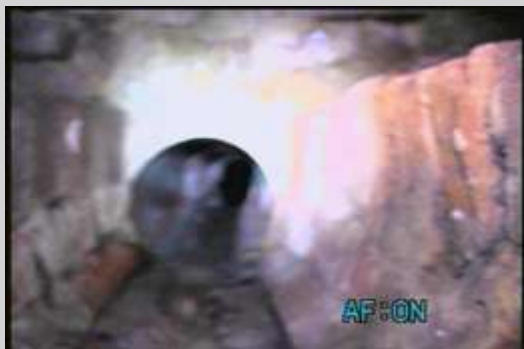
6 O'Clock Inflow

8 in. Circular Gravity Sewer
Pipe In @ 6 O'Clock

Invert Depth: **9.90** (ft.) Flow Characteristics: **Slow**

Infiltration: **None** Pipe Seal Cond: **Unknown**

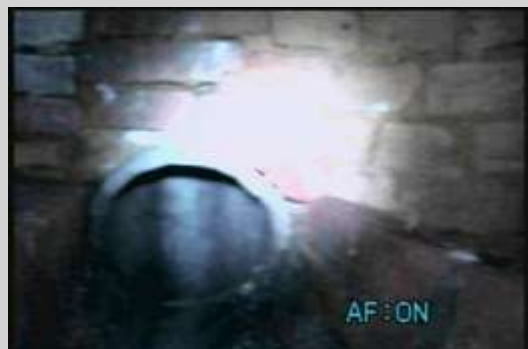
9 O'Clock Inflow

8 in. Circular Gravity Sewer

Pipe In @ 9 O'Clock

Invert Depth: **9.75** (ft.) Flow Characteristics: **Slow**

Infiltration: **None** Pipe Seal Cond: **Unknown**
